### History of the Daimler Dingo Scout Car

The **Daimler Scout Car**, known in service as '**the Dingo**' was a light fast reconnaissance vehicle also used in the reconnaissance liaison role during the Second World War.

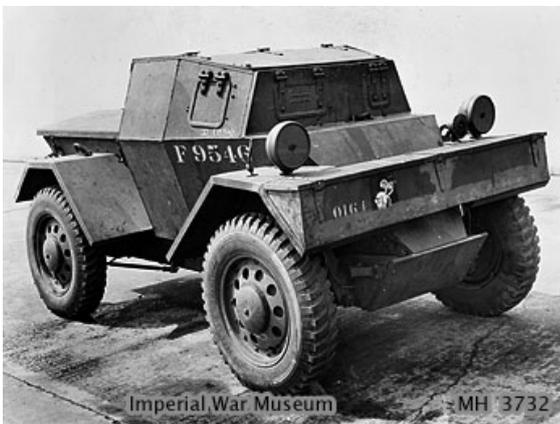
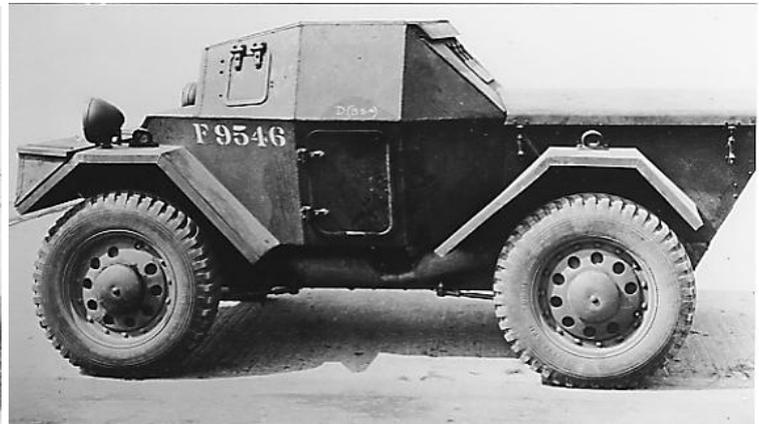
(Photo sourced from Internet, known to also exist in the Bovington Library & IWM Reference MH3732 & )  
Daimler Mk I scout car **F9546** of the 2<sup>nd</sup> Armoured Division.

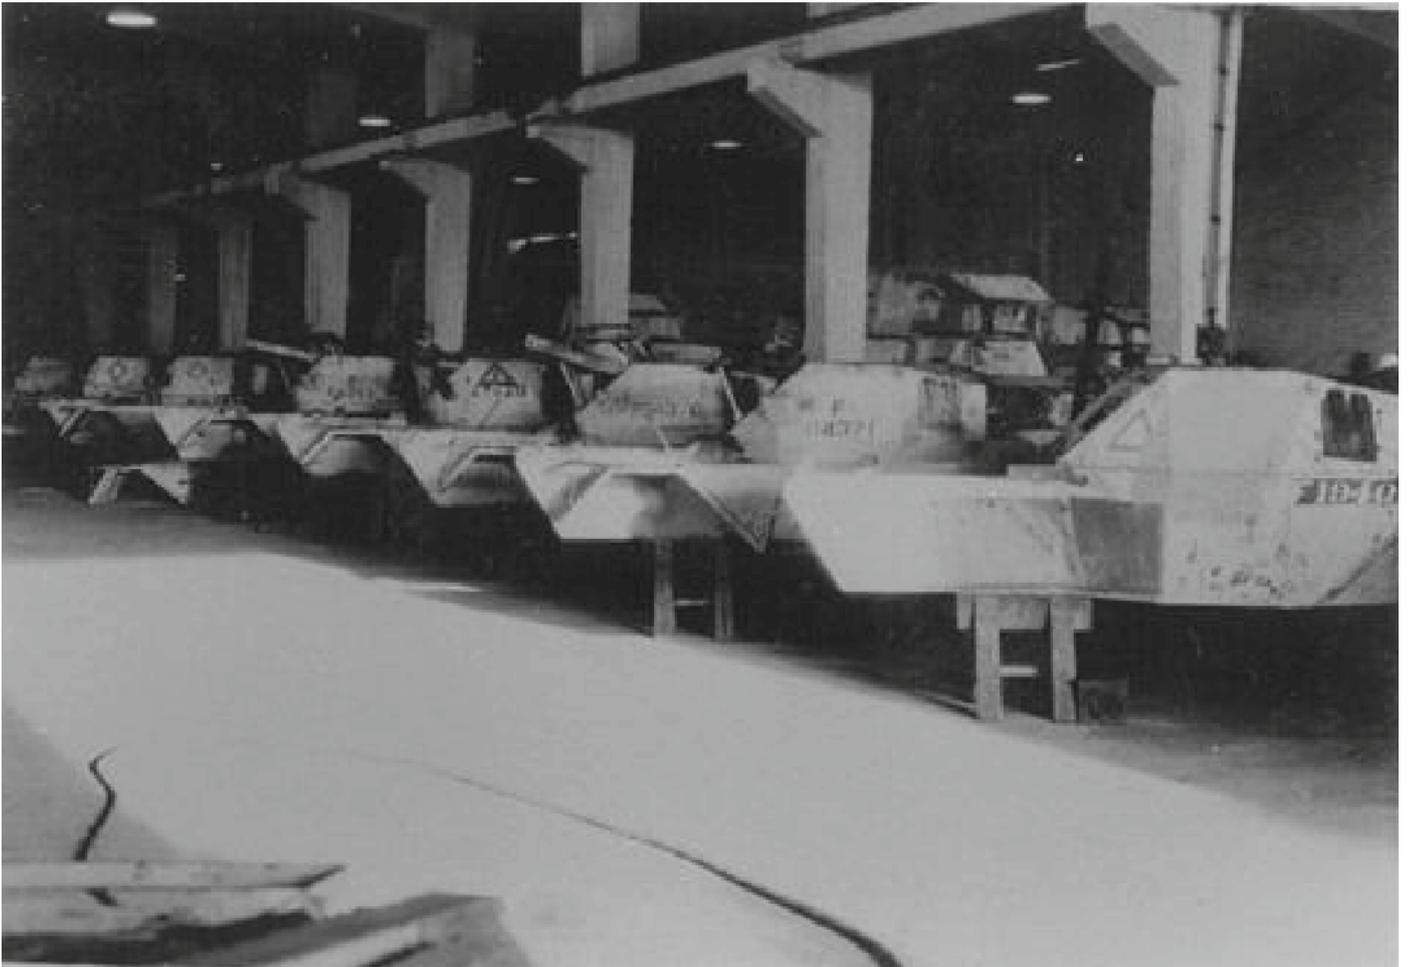
(Photo sourced from Internet, known to also exist in the Bovington Library-)

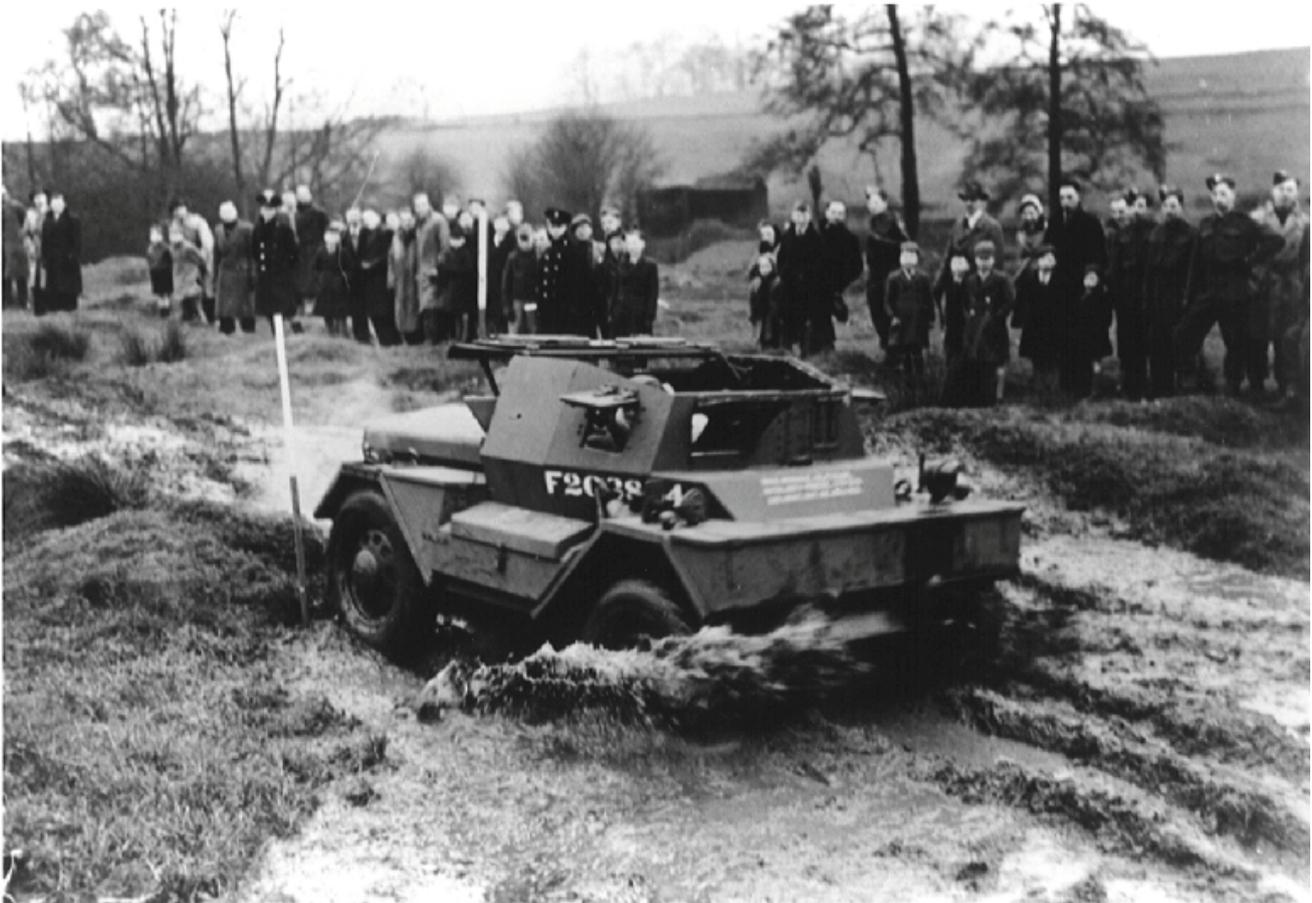
(Image courtesy Bovington Tank Museum)
