## The Daimler Dingo Scout Car– Design & Development Fighting Vehicles Project – Part Aa2 [www.daimler-fighting-vehicles.co.uk](http://www.daimler-fighting-vehicles.co.uk)

### Servicing and Training

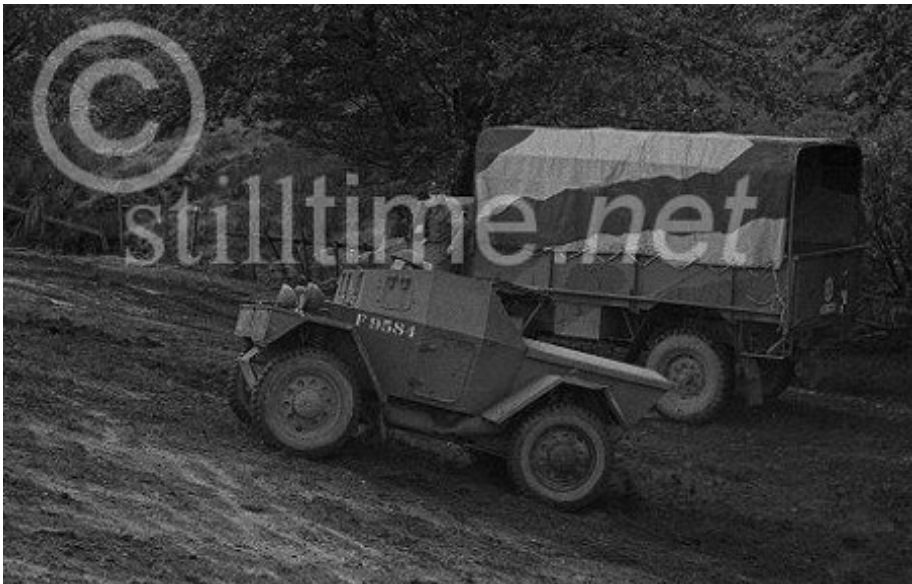
### **F9584 ,MkIA, circa 1940**

The vehicles are at the "D & M School Harrogate" approximately 1941

It is assumed that D&M is an abbreviation of Driver and Maintenance and the photo was taken somewhere on the adjacent Yorkshire Moors

A rare photo of fitters of the RTR maintaining their car  
(Photo sourced from Internet,

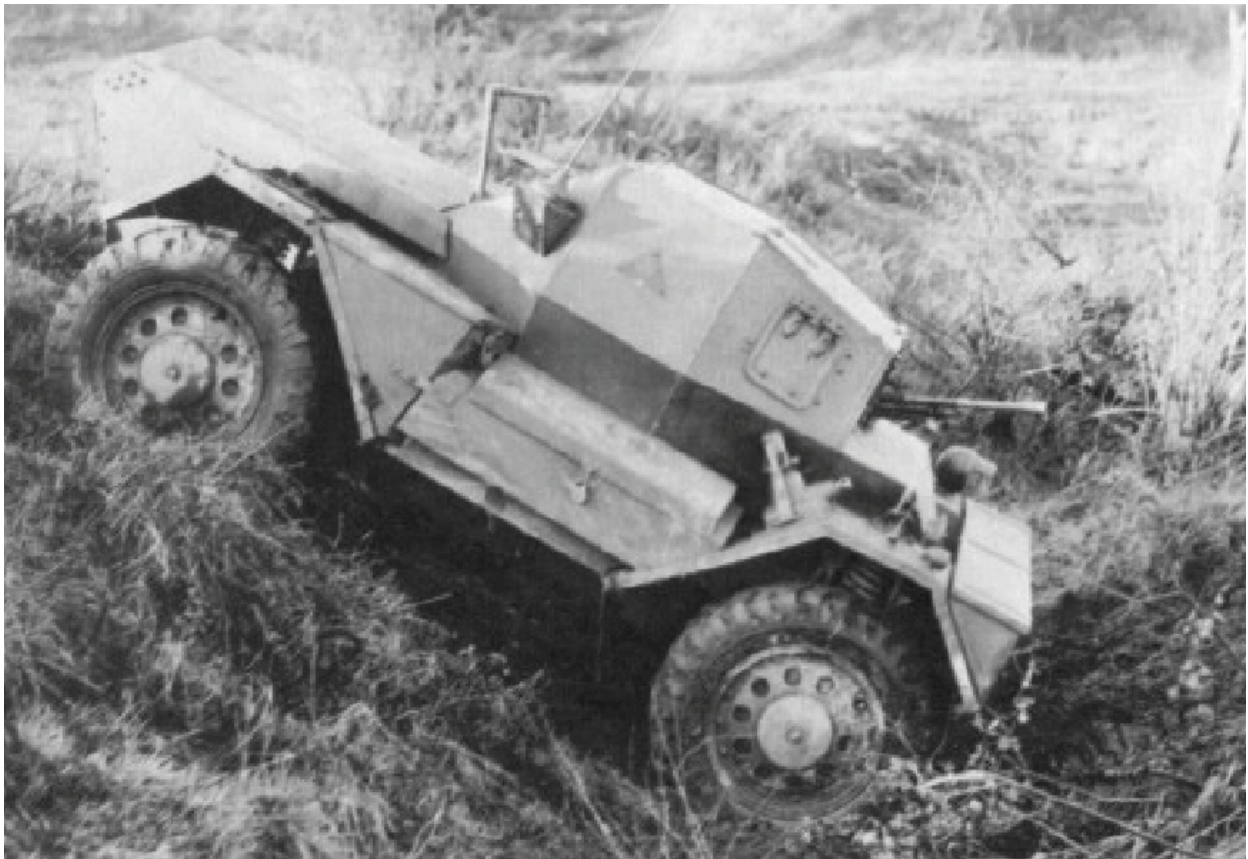
(Image courtesy Bovington Tank Museum)  
Photographer: by the B MOT ARM Daimler Car Co.  
Ditch crossing trials and training.

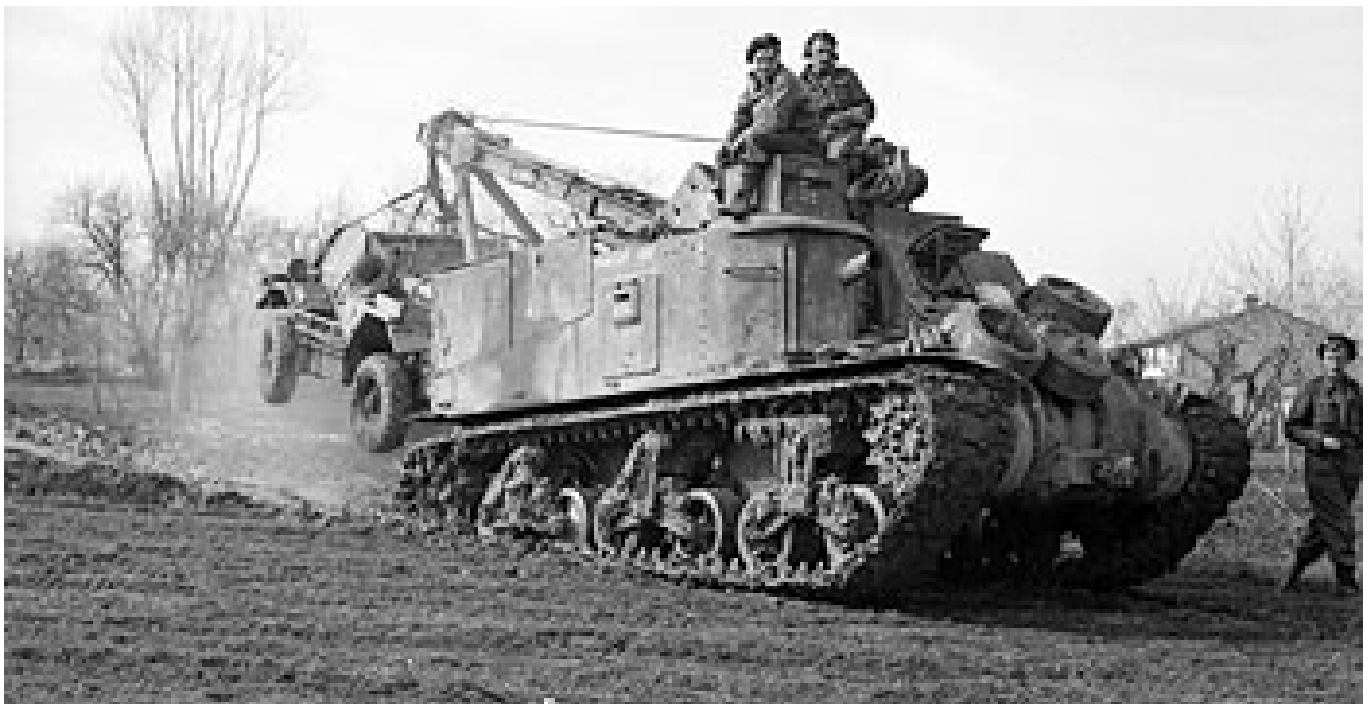
Photographer: Lambert (Sgt) of No 2 Army Film & Photographic Unit  
Description: A Grant ARV of the New Zealand Division lifts a Daimler scout car, which had become bogged down in the mud near Faenza, 7 February 1945.

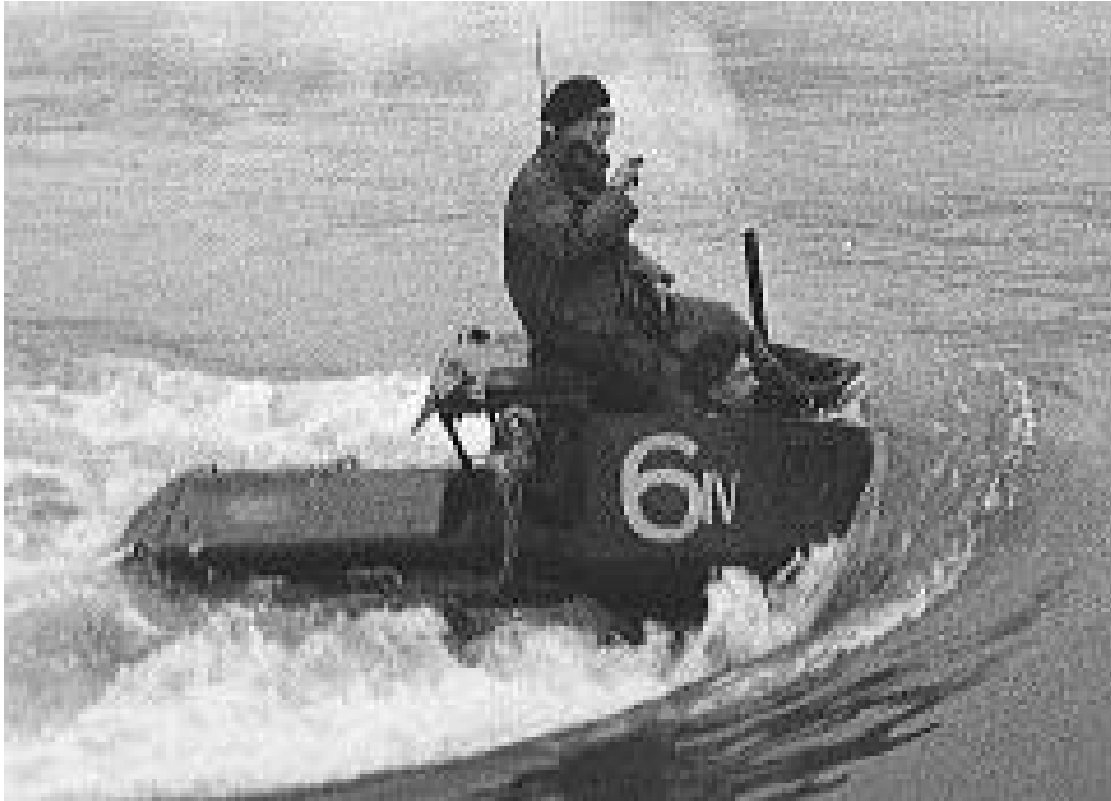
Photo Courtesy of the Tank Museum photo No. 4201/A/5  
Waterproofing and fording trials and training, probably held in the sea of Weymouth

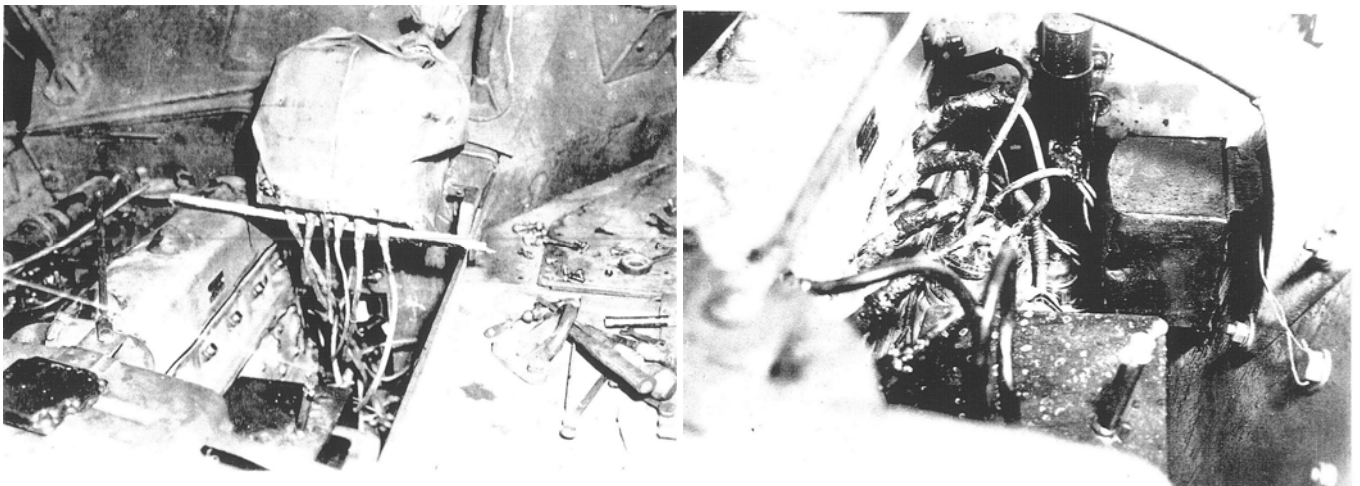
By the bagging of certain items like the electrical regulator and the liberal application of pitch bitumen the engine and electrical connections were made to be water tight

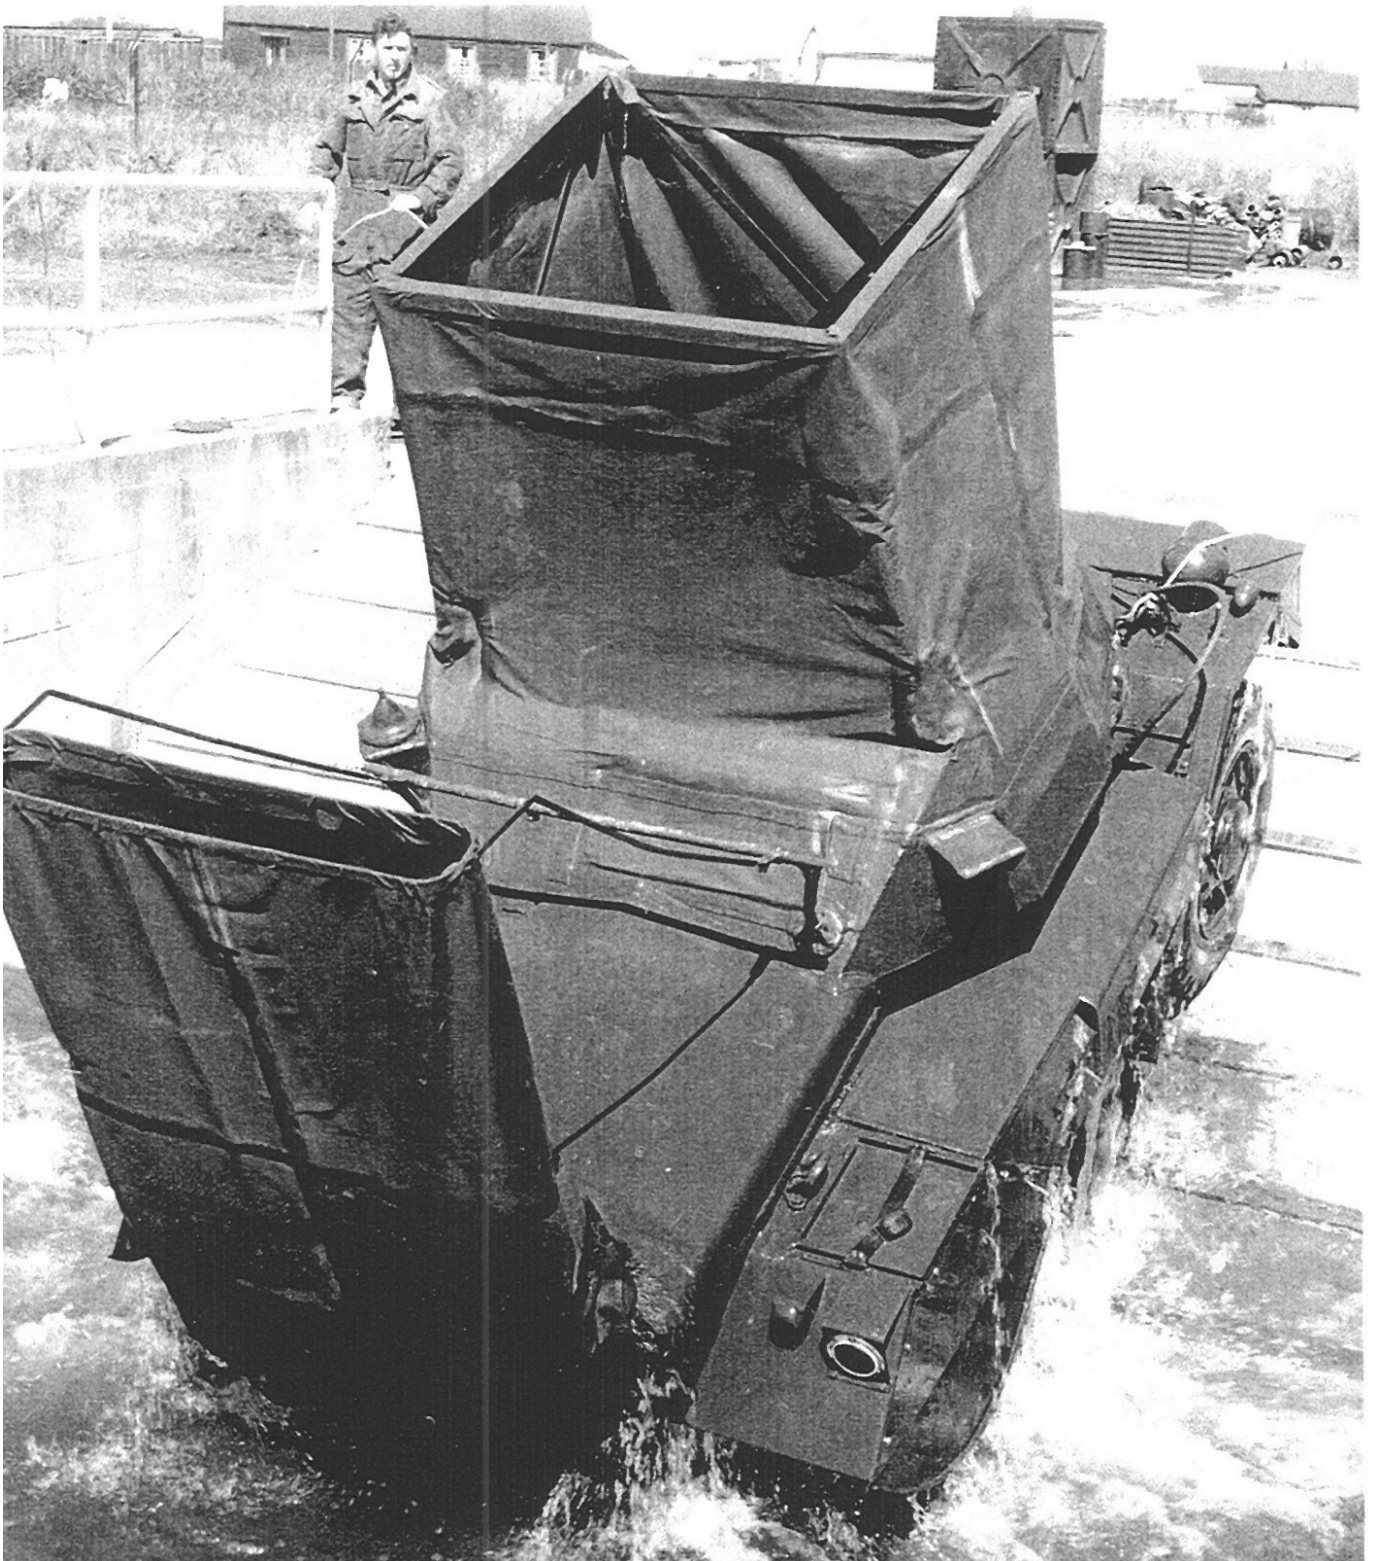
As part of the preparations for D-Day the dingo was modified to be able to deep wade through at least 10 feet of water, here the vehicle exits the water after a trial at the research testing centre

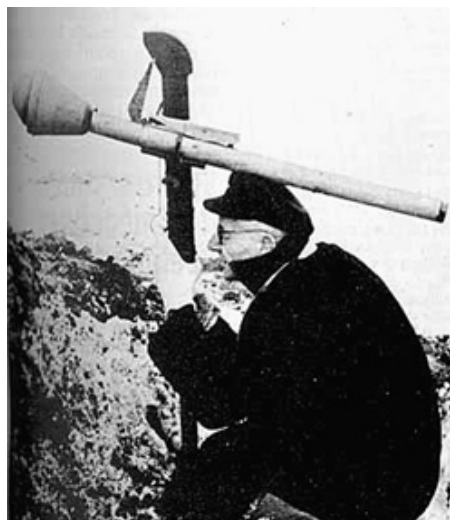
Description: A sight feared by both Armoured car and Dingo Crew, The Panzer Faust was an inexpensive, recoilless German anti-tank weapon. It consisted of a small, disposable preloaded launch tube firing a high explosive anti-tank warhead, operated by a single soldier

The armour was not sufficient however to protect against Solid artillery (SA), high explosive artillery (HE) squash head warheads typically found in anti tank munitions during the early part of world war two. More alarmingly it provided little protection against the newly developed hollow charge weapons such as the German Panzerfaust.

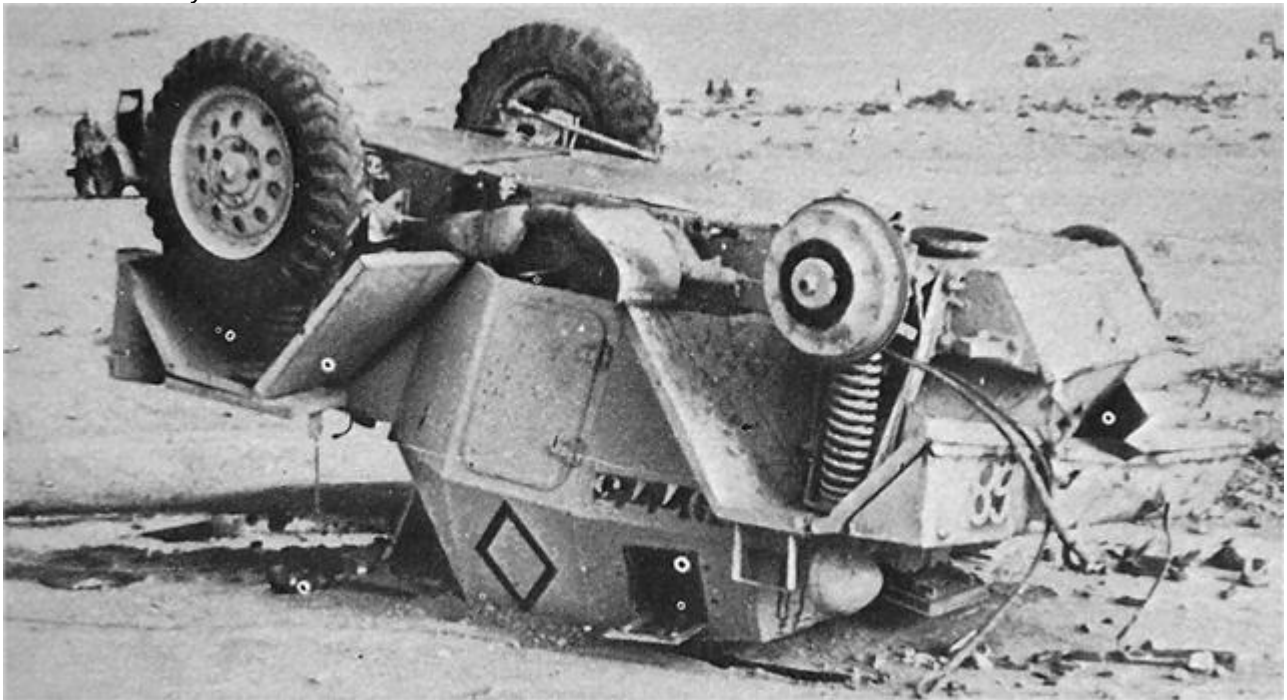
Description: Yet another mined scout car (F9773) somewhere in North Africa

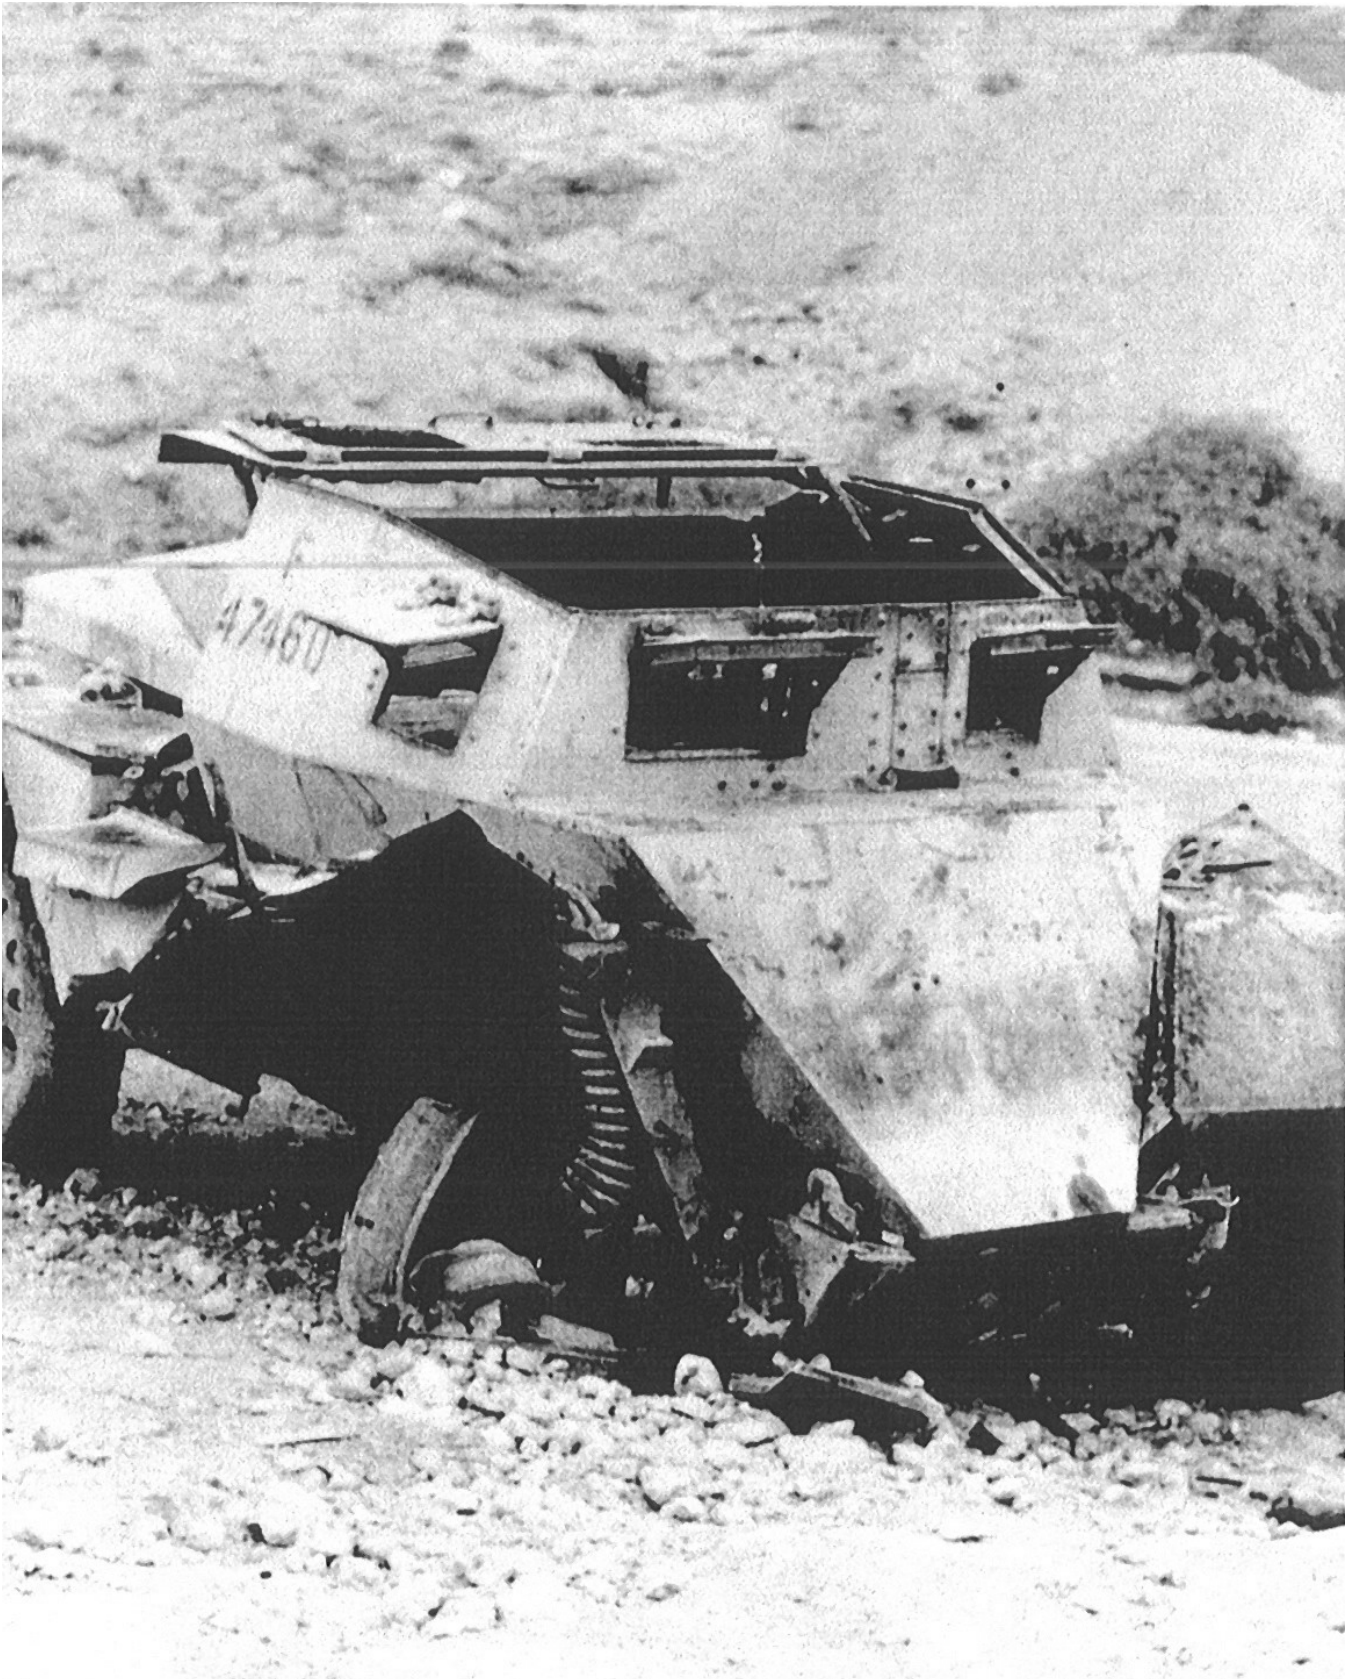
Description This Dingo (F47460) has run over a land mine in the North African Campaign, entirely removing the front bin, most of the wing and severely twisting the chassis and cracking the armoured plate at the back of the cabin to the rear of the fuel tank.

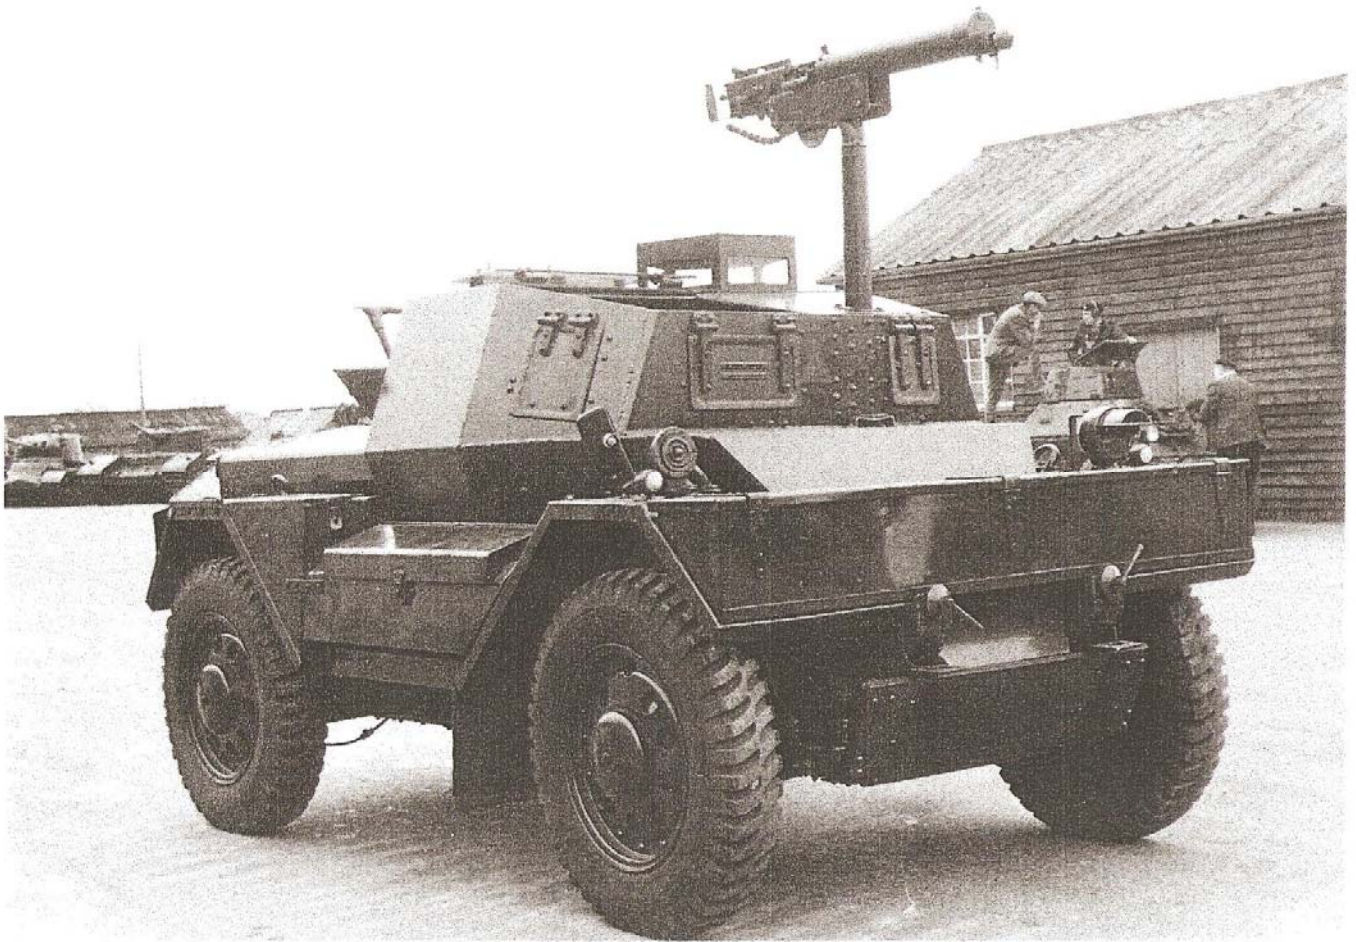
Description: In the 1950's trials were held to fit more effective armament and also increase the level of protection; this was necessitated by the use of the vehicles in enclosed locations such as the Jungles of Malaya.

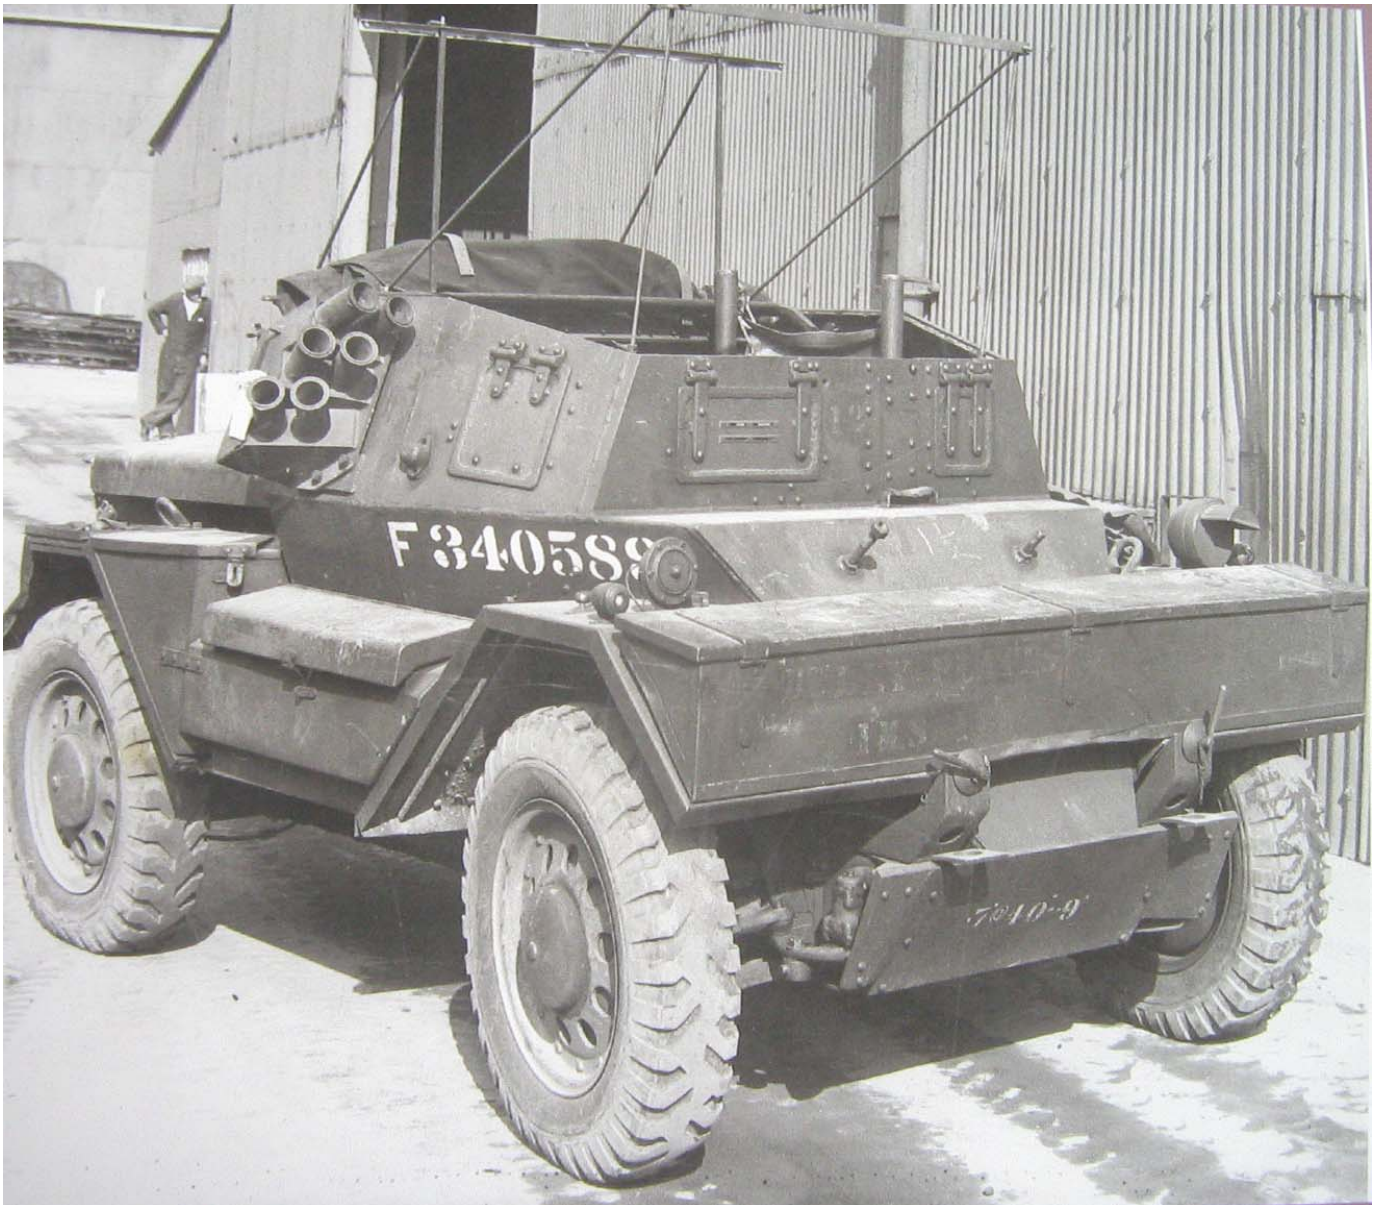
Description: this photo of Dingo F340589 shows a strange framework above the turret, possibly for the addition of wading screens but the assembly does not look to be robust enough to resist much water pressure? Also odd are the two studs welded to the frontal armour above the front bin.

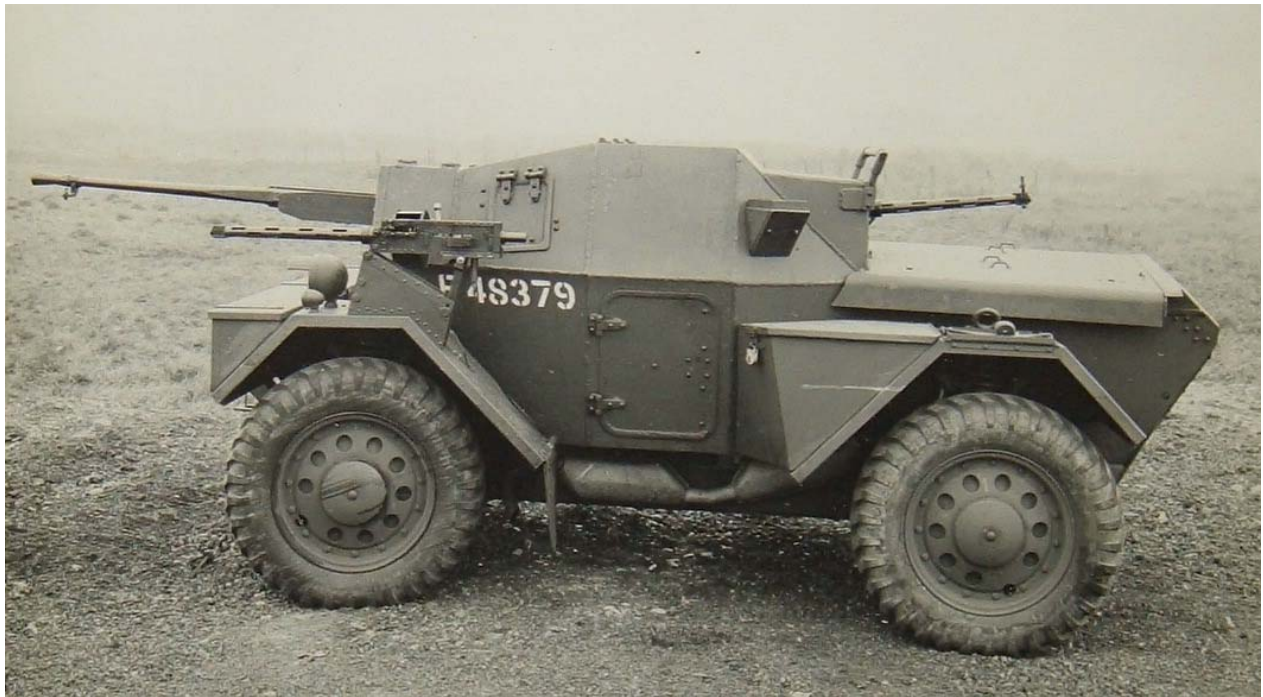
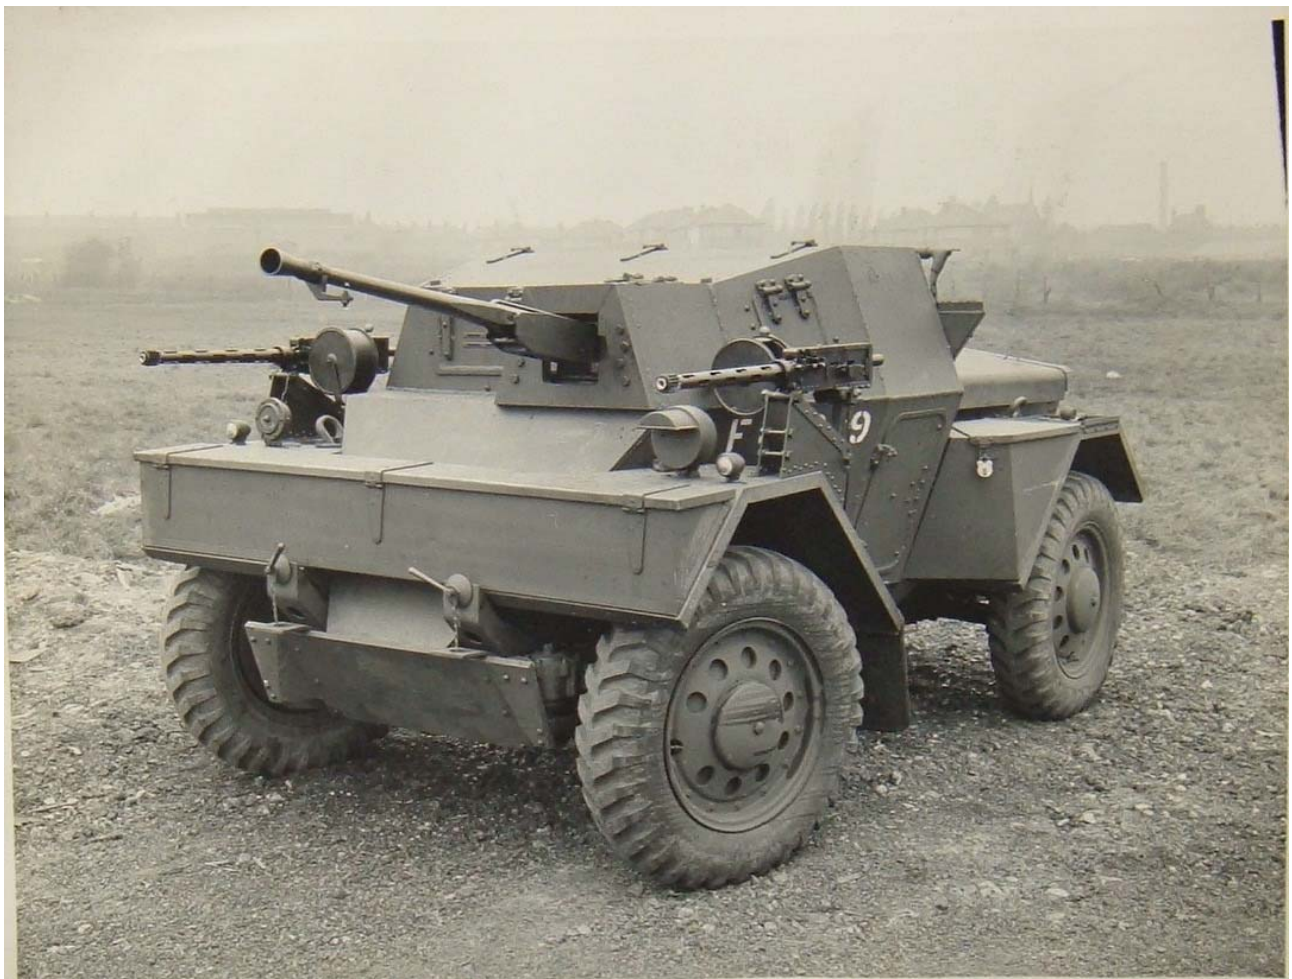
Description: What is presumably the most heavily armed Dingo (F48379) ever created.  
Specification, twin aircraft 303 sponson mounted browning MGs, single 303 browning MG to the rear and  
a .5 BESA heavy MG as main armament!  
Date Unknown.
